CITY OF NORWALK

Operation and Maintenance Program

APRIL 2009

AKM CONSULTING ENGINEERS
553 Wald
Irvine, California 92618
(949) 753-7333

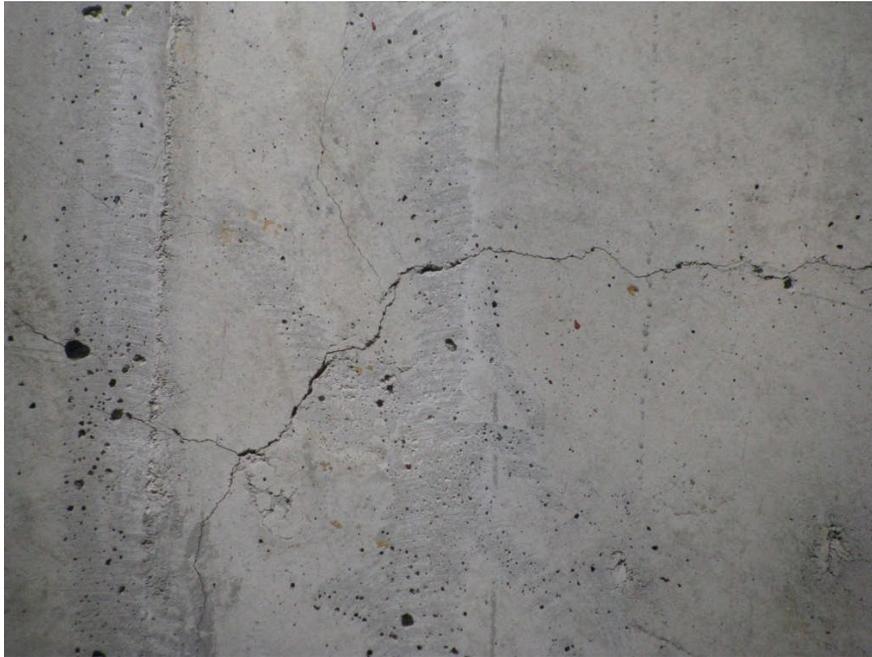
Minor cracking of the northerly reinforced concrete wall, shown on Photo III-1, was observed during the field investigation conducted on October 22, 2008.

**Photo III-1
Minor Cracking on Dry Well Wall**

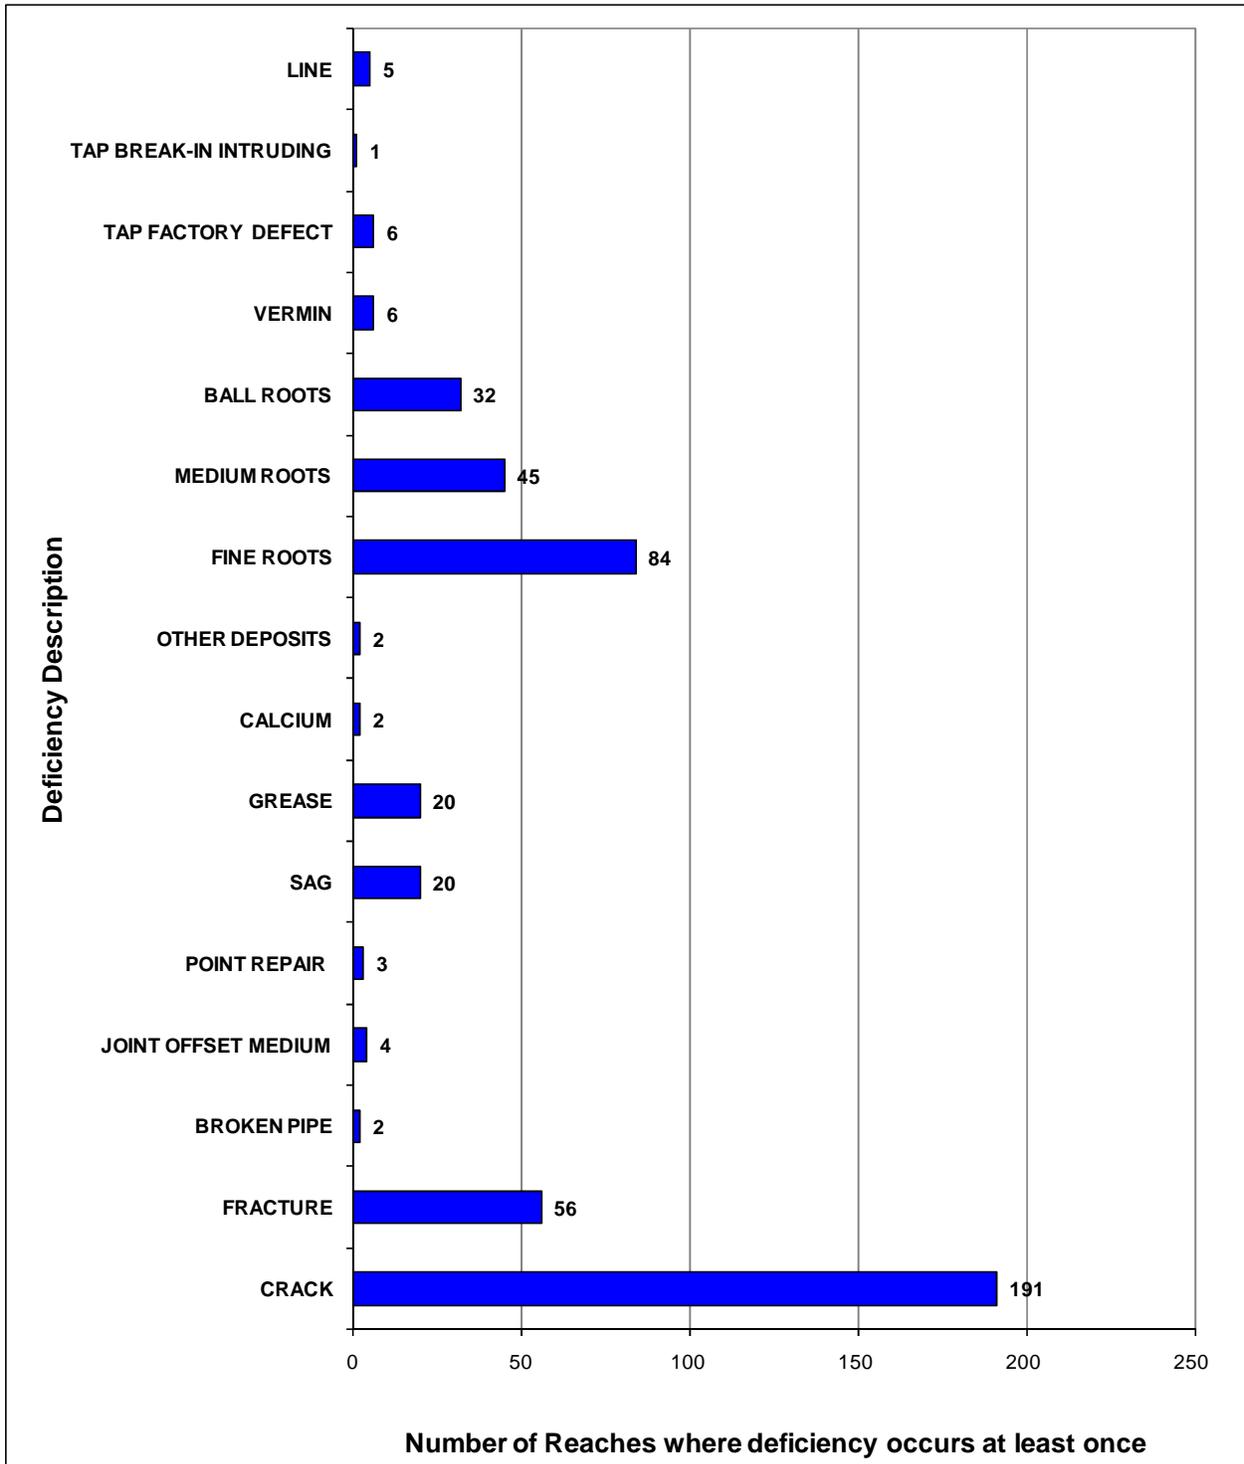
**Figure III-5
Sewer Reaches with Identified Deficiencies**

Figure III-5 shows the number of reaches where an identified deficiency was found at least once within the reach. It provides a general sense of the magnitude of the problems that were found in the portion of the City's collection system that was CCTV inspected in 2008. The problems identified most often were cracks (191 reaches, 45% of total inspected) and fine roots (84 reaches, 20% of total inspected).

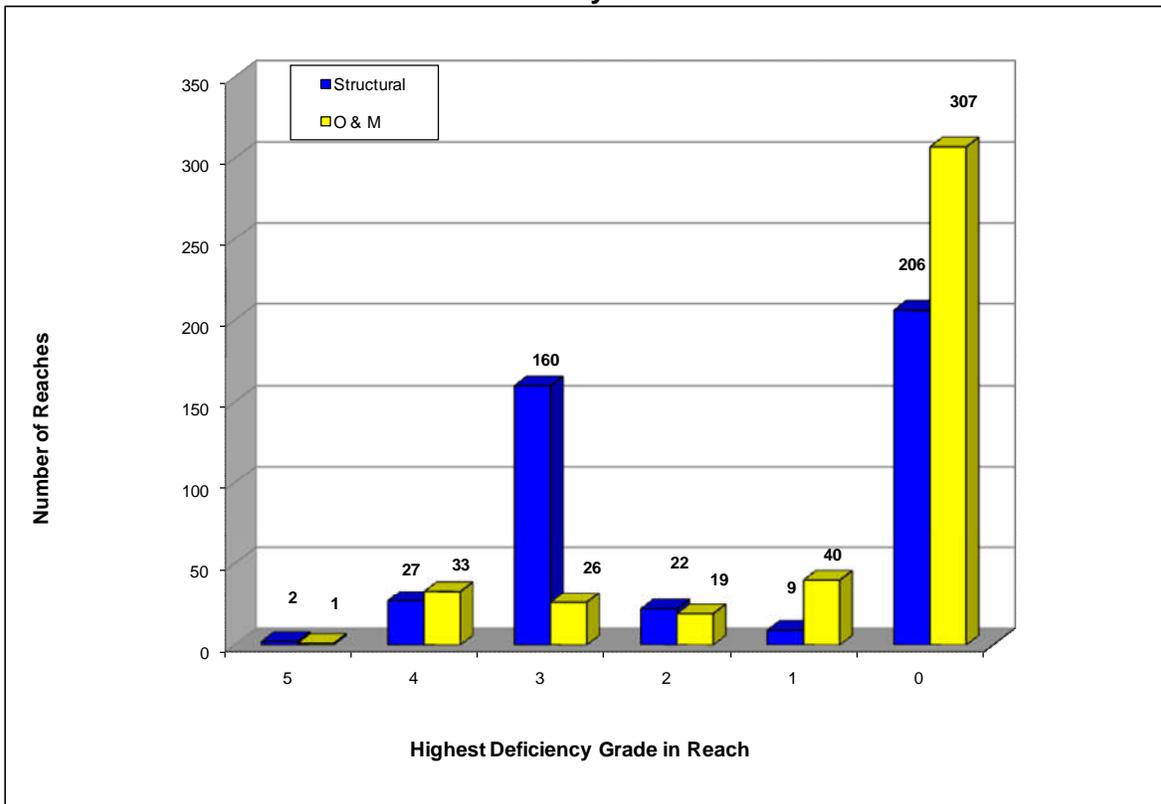
**Figure III-6
Deficiency Grades**

Figure III-6 plots the number of reaches versus the highest deficiency grades found in each reach. For example, there were 2 reaches found with at least one structural deficiency grade of 5 and 1 reach found with at least one operation and maintenance deficiency grade of 5.

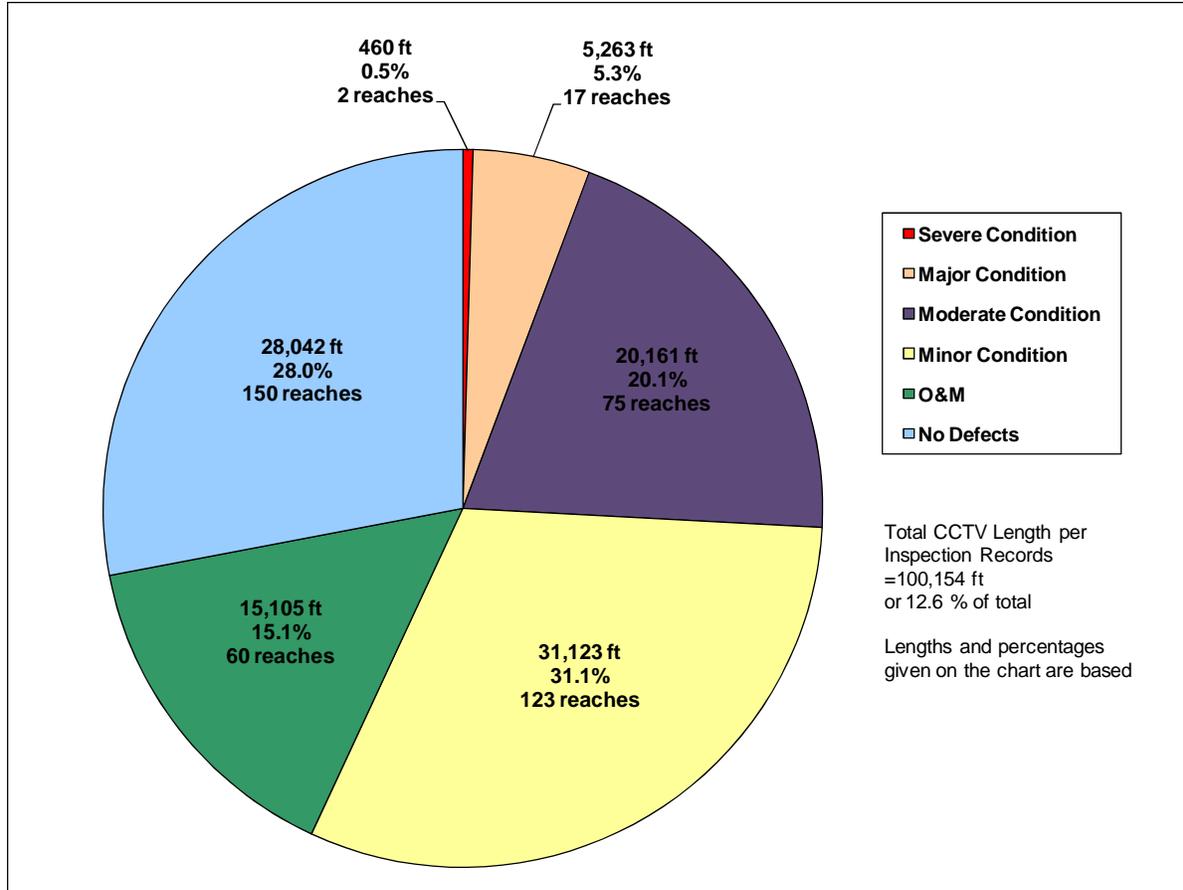
**Figure III-7
CCTV Inspection Priority Ratings**

Figure III-7 shows the distribution of the condition ratings assigned to the CCTV Inspections. Figure III-8 shows the CCTV locations, color coded by rehabilitation/replacement priority.

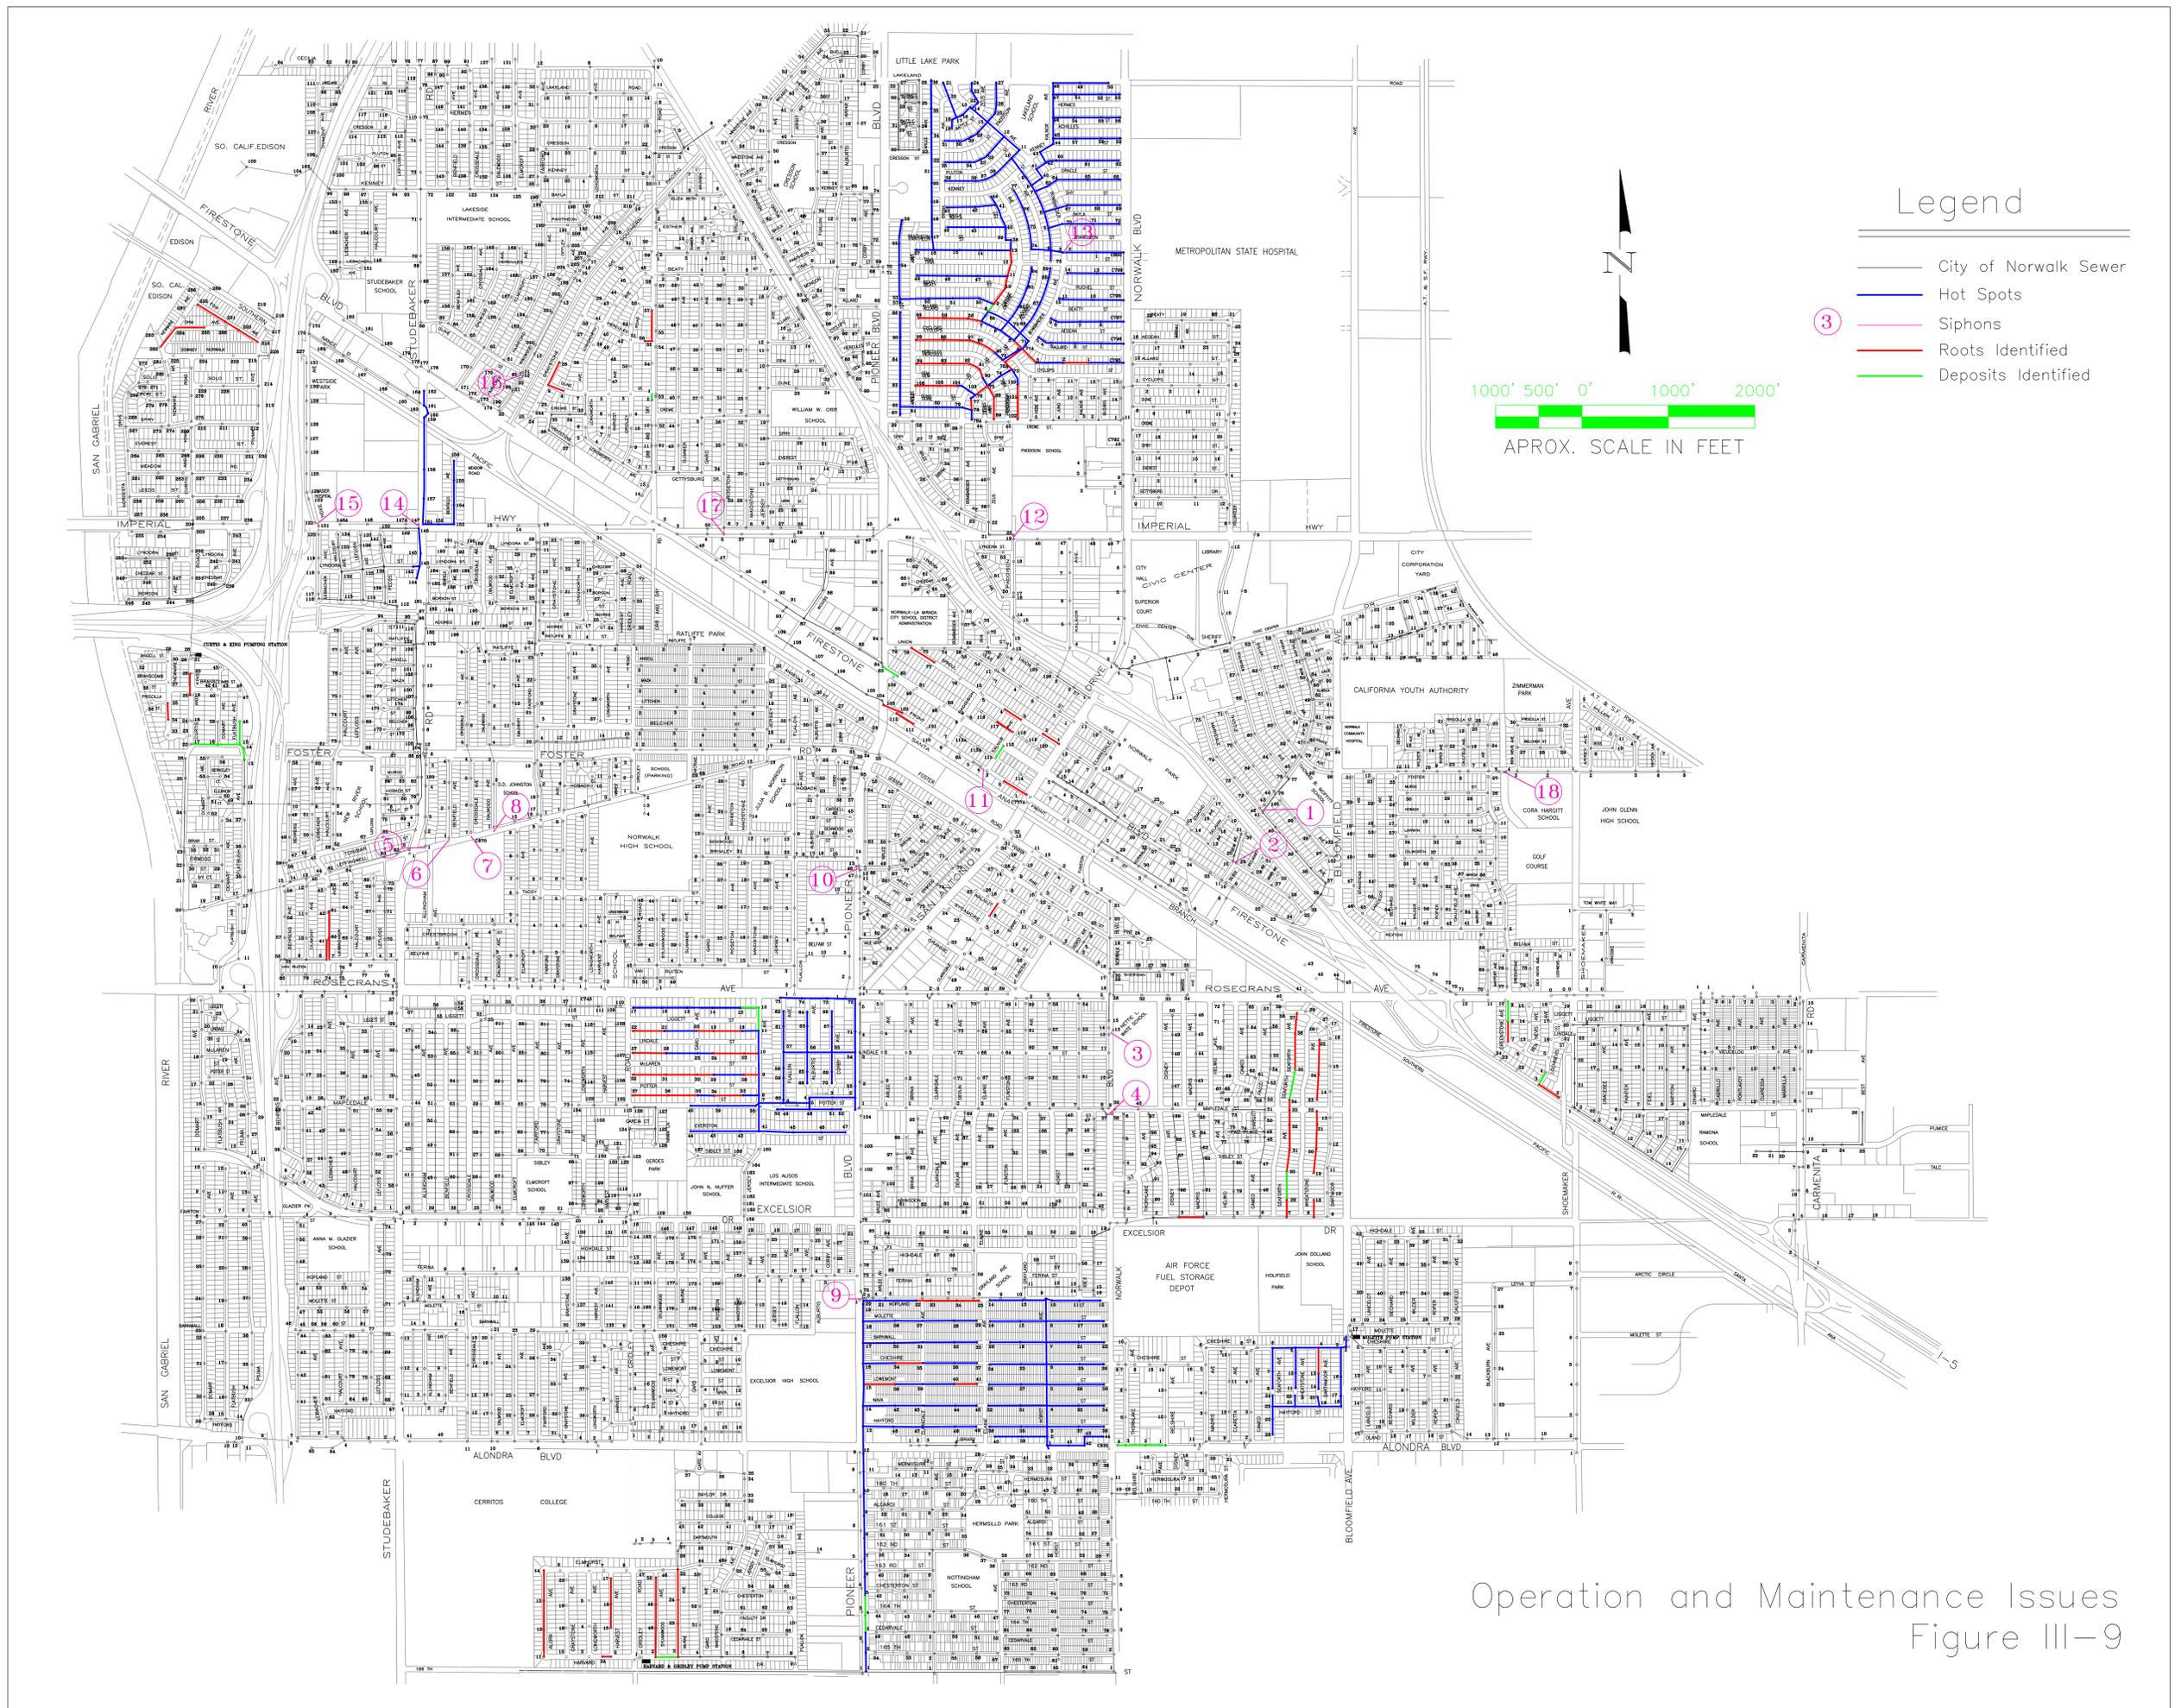
Figure III-9 illustrates the locations of roots, grease, deposits, and obstacles that were found through CCTV inspections. These conditions, along with siphons, are the cause of many of the frequent maintenance areas (hot spots). The siphons and City hot spots are also shown on Figure III-9.

The locations listed in Table III-4 have been added to the City's Hot Spot list as part of its preventative maintenance program. Although no spills have occurred at some of these locations, the presence of sags, grease, deposits, and other defects may cause spills in the future. These locations will be re-inspected within six months following the initial cleaning effort, and a long term maintenance program will then be formulated.
